Operation TEAPOT

Project 31.2

DAMAGE TO COMMERCIAL AND INDUSTRIAL BUILDINGS
EXPOSED TO NUCLEAR EFFECTS

Bruce G. Johnston

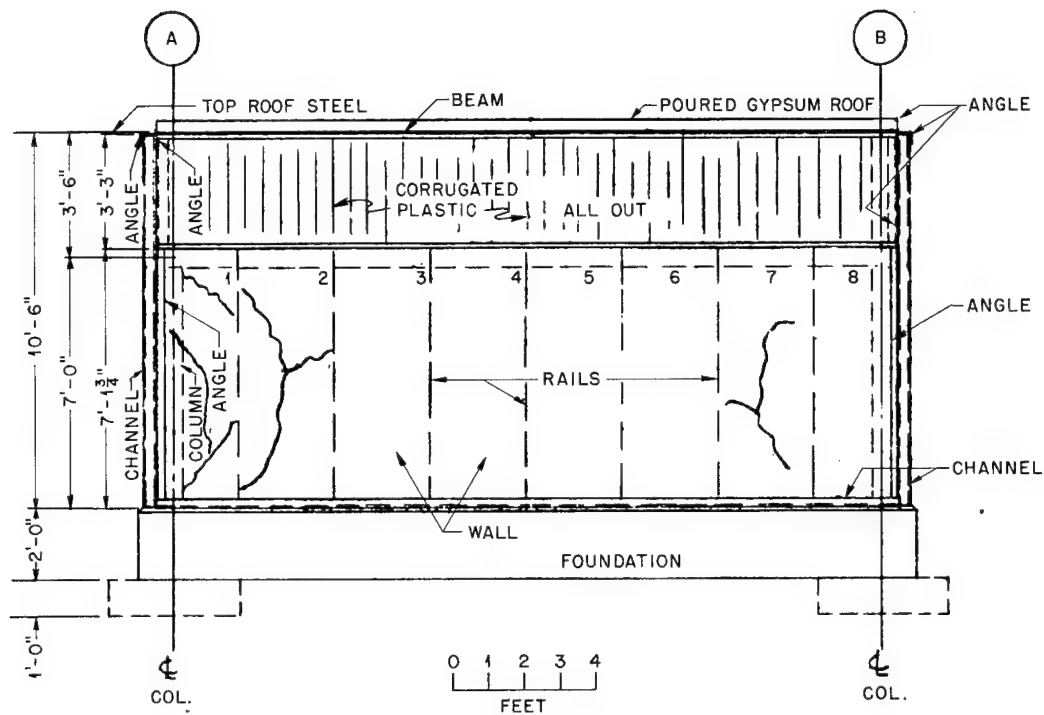
Fig. 1.3—Front elevation of Union Carbide building.

The reinforced-gypsum walls suffered only slight damage. The wall facing the blast (Fig. 1.3) showed moment cracks on the interior surface. These cracks were a maximum of $\frac{1}{32}$ in. in width, and they occurred in three of the panels formed by the vertical steel rail studs. The south wall, away from the blast center (Fig. 1.4), developed a horizontal crack approximately $\frac{1}{16}$ in. in width, starting near the southeast building column and extending across one-third of the bay. The east and west walls showed no moment cracks, but several shear cracks developed in the west wall at the top of the panels at roof level near the door opening, as shown in Figs. 1.6 and 2.16.

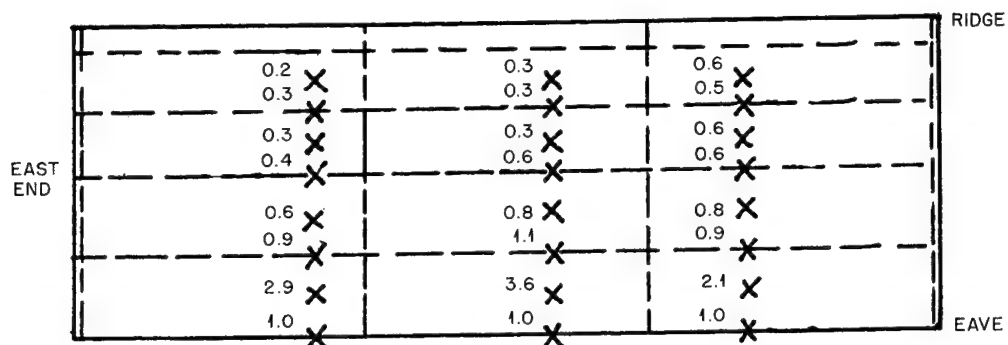
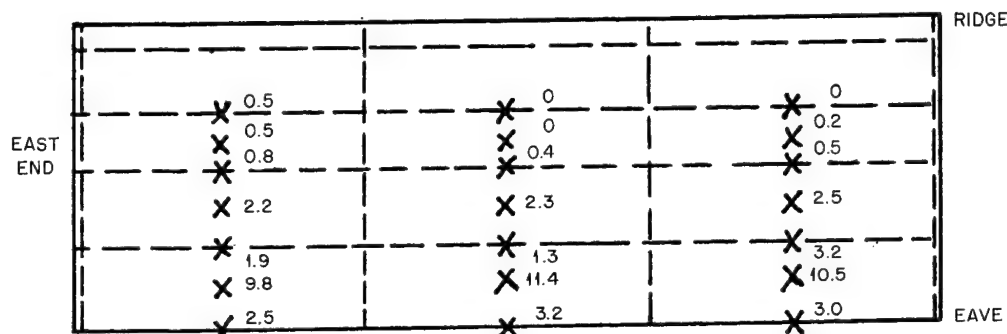
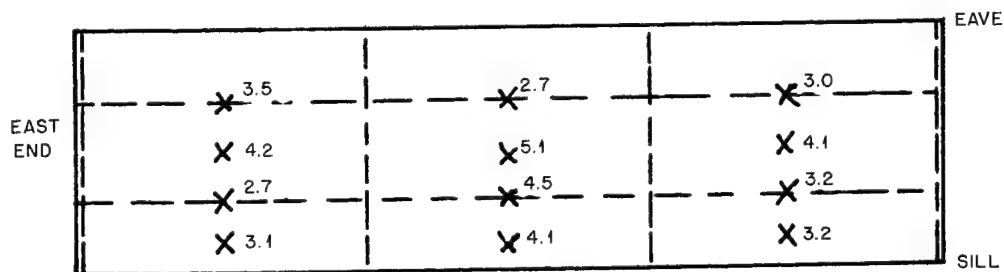
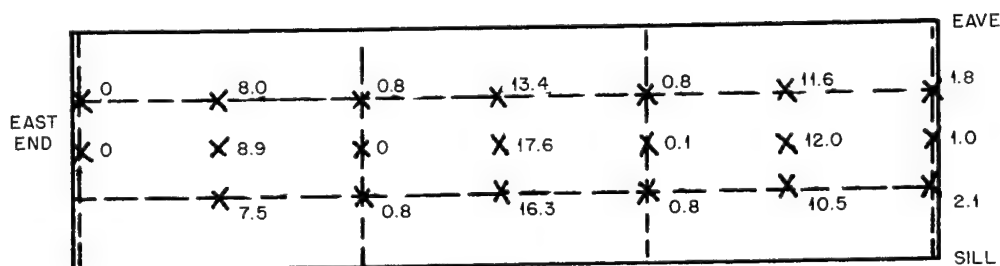
Fig. 2.2—Offset measurements of permanent wall and roof deflections in inches in Reynolds-Butler buildings in which sheeting remained in place.

Figure 2.1 gives a general indication of the damage from the unexpected test to the north wall of Reynolds-Butler Building 31.2-a1, which was left with permanent inward deflections up to 5 in. The offset measurements, as recorded at the site, are tabulated in Fig. 2.2 for both the unexpected and planned tests. The two wall girts were bent in along with the paneling, and the bolt heads of the panel fasteners were generally pulled through the sheeting. Washers had been omitted along these two lines of bolts, and hence no definite conclusion can be made as to the probable extent of pull through if they had been included. The roof sheeting was left with downward permanent sets, especially in the span immediately adjacent to the eaves, where the permanent deflections, as shown in Fig. 2.3 and recorded in Fig. 2.2, were measured up to 3 in. The roof purlins were not deformed appreciably. The interior view of the wall (Fig. 2.4) shows how twisting of the girts occurred with measured values up to 43°. It is also of interest to note the imprint of the wind-bracing ties on the wall paneling, indicative of the initial deflections that were experienced. A dynamic analysis of wall behavior in both the unexpected and planned tests is provided in Appendix A.

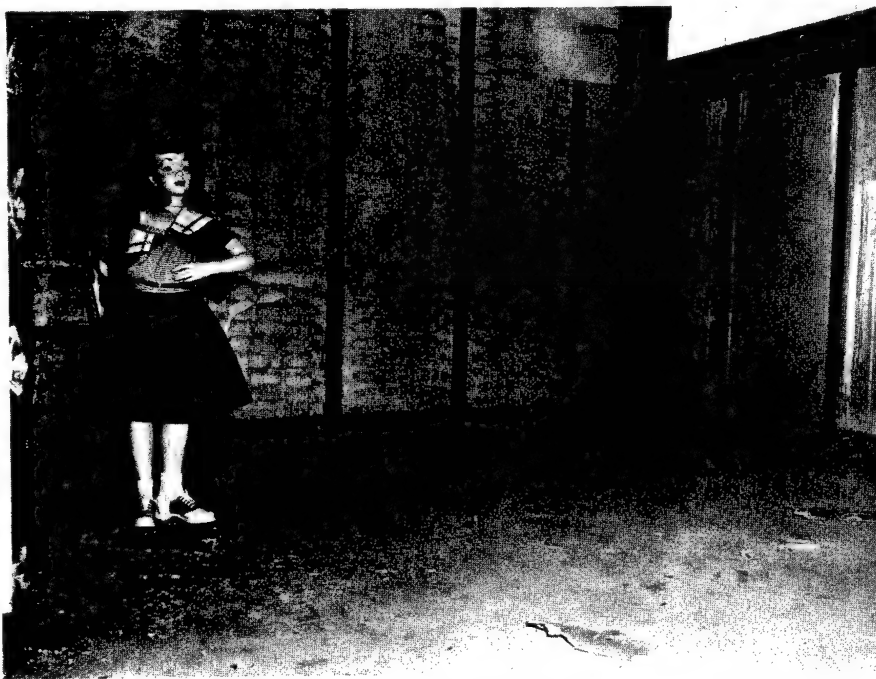
A mannequin standing erect in the center of the building was still erect and virtually unharmed after the blast, as shown in Fig. 2.13. The stylus points of three of the four scribes were destroyed, but general indications were obtained as to movements of structural members.

Fig. 2.13—Interior view of southeast corner of Union Carbide building after planned test.

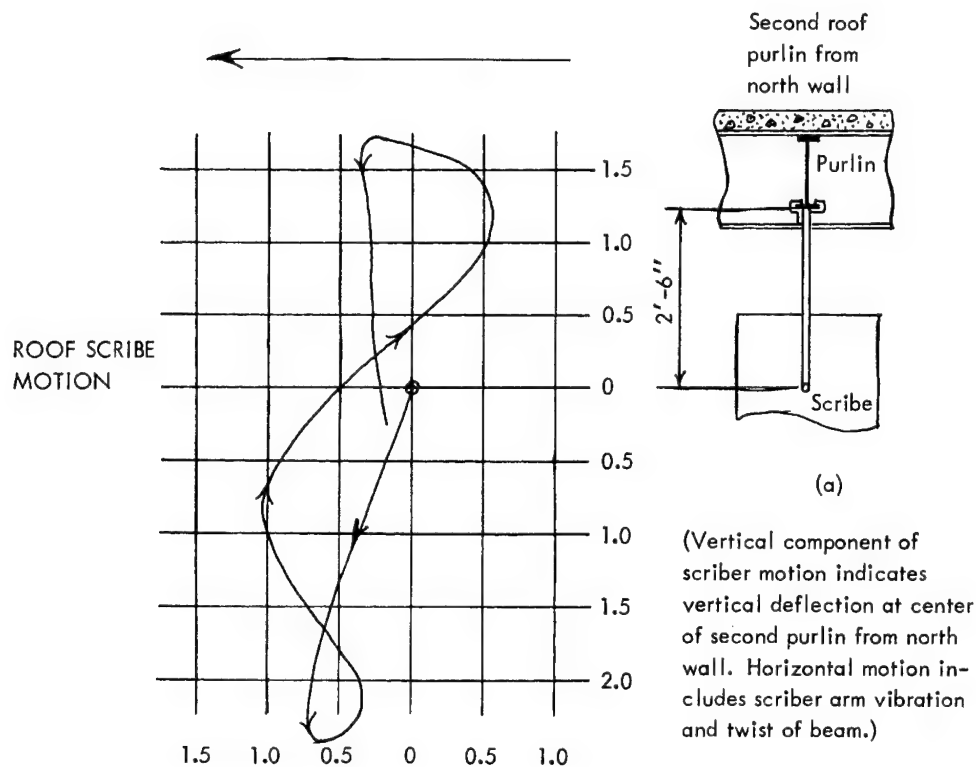
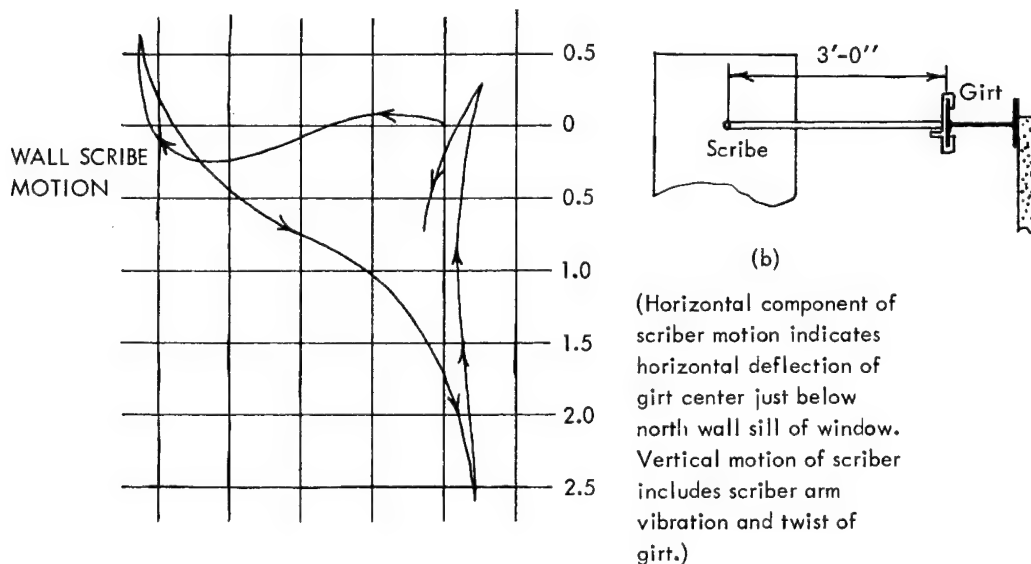
Severe vertical roof movements were indicated on scratchboards, and these movements are recorded in Fig. 2.14 at the one available location. No permanent deflections were recorded for any roof beams, except for the beam one panel from the south wall, which had a permanent upward deflection of $\frac{1}{8}$ in. at the center of the beam.

1. Horizontal girt in north wall: torsion and horizontal deflections, as shown in Fig. 2.14.
2. Roof girder at east wall: torsion in the girder, as shown by the impact mark on the scratchboard by the stylus pipe arm.
3. Roof beam, just north of center line: vertical displacement coupled with some torsional movement, as shown in Fig. 2.14.
4. Column in southeast corner (near girder): displacement approximately $\frac{1}{4}$ in. in north and south directions.

SCRIBE MOTION SHOWN FULL SCALE—
NUMBERS INDICATE INCHES FROM INITIAL LOCATION

Fig. 2.14—Deflections of roof and north wall in Union Carbide building during planned test.

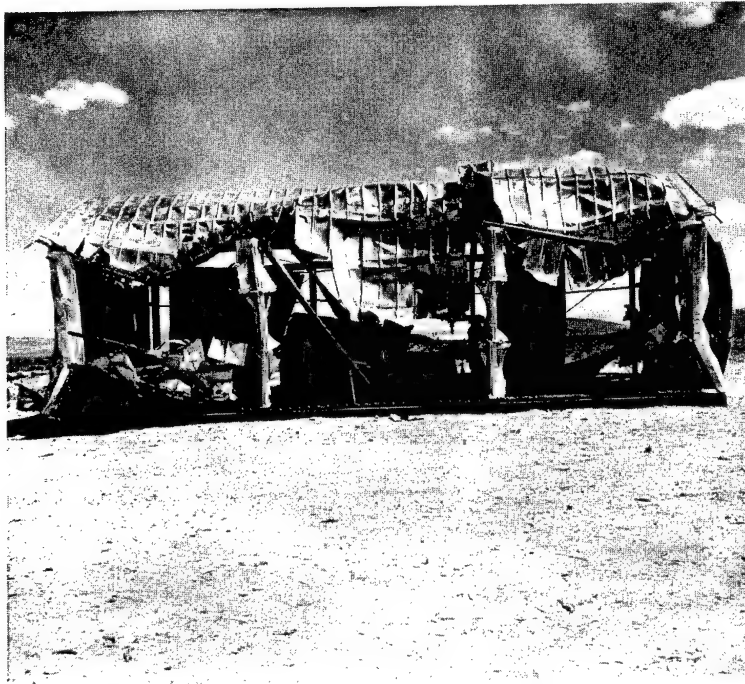
Fig. 2.17—North side of Reynolds-Butler Building 31.2-a1 after planned test.

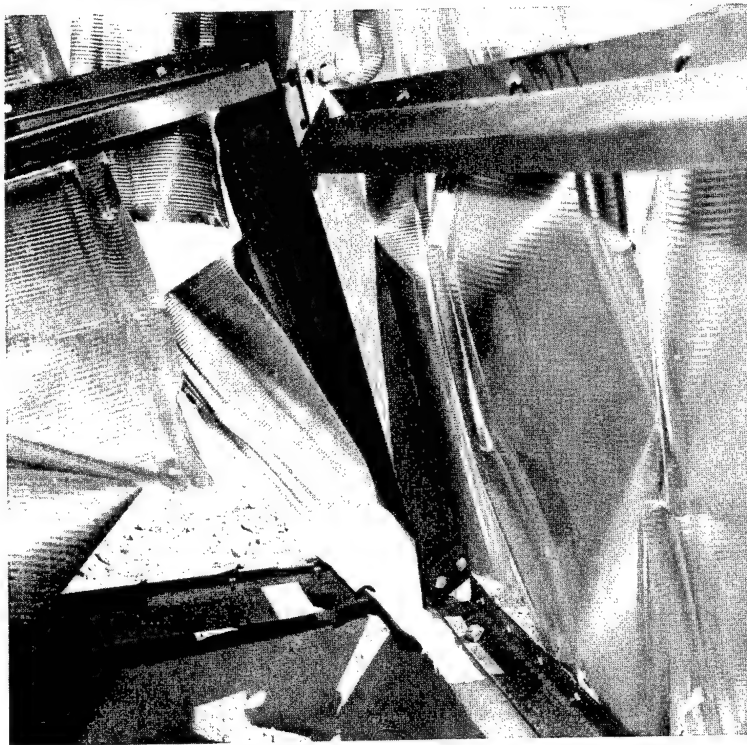
Fig. 2.18—Interior detail of northeast column in Reynolds-Butler Building 31.2-a1 after planned test.

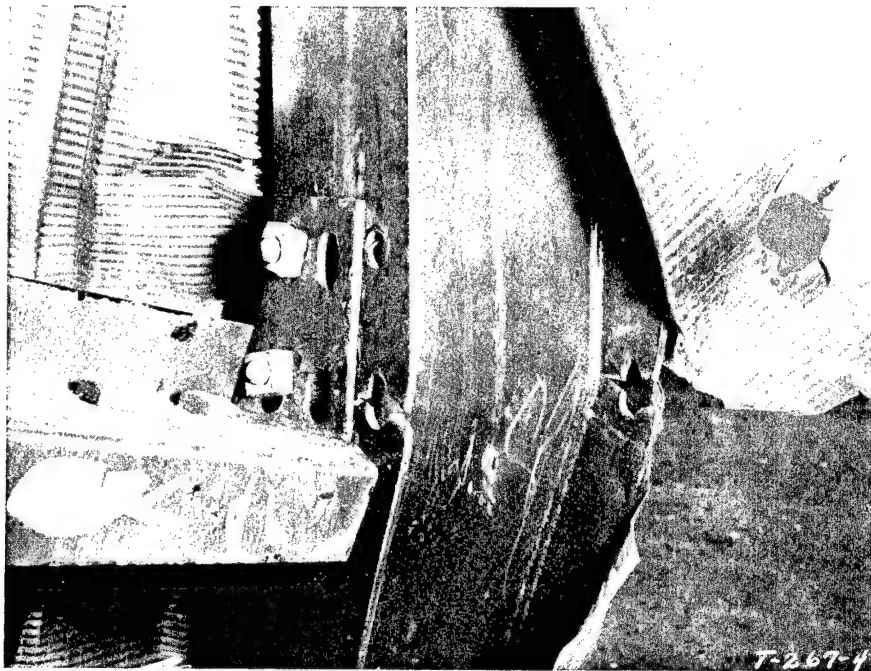
Fig. 2.19—Interior detail of northwest column in Reynolds-Butler Building 31.2-a1 after planned test.

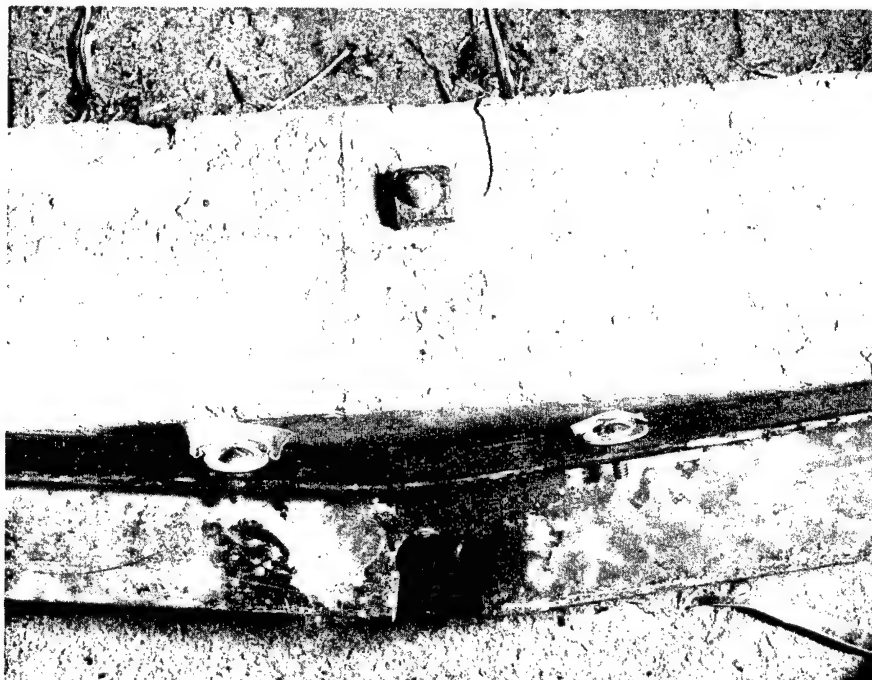
Fig. 2.20—View looking down on sill angle in Reynolds-Butler Building 31.2-a1 after planned test.

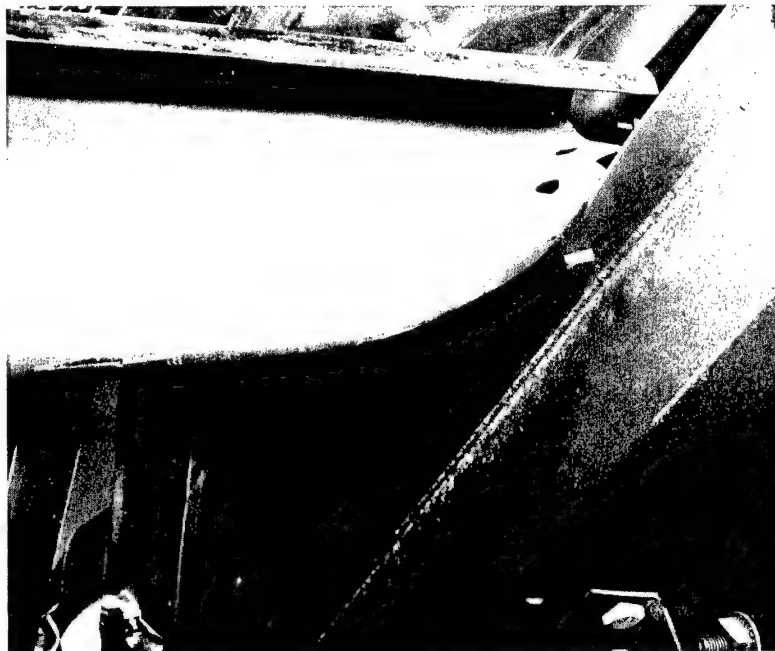
Fig. 2.24 —End crippling of purlins at northeast corner of Reynolds-Butler Building 31.2-a1 after planned test.

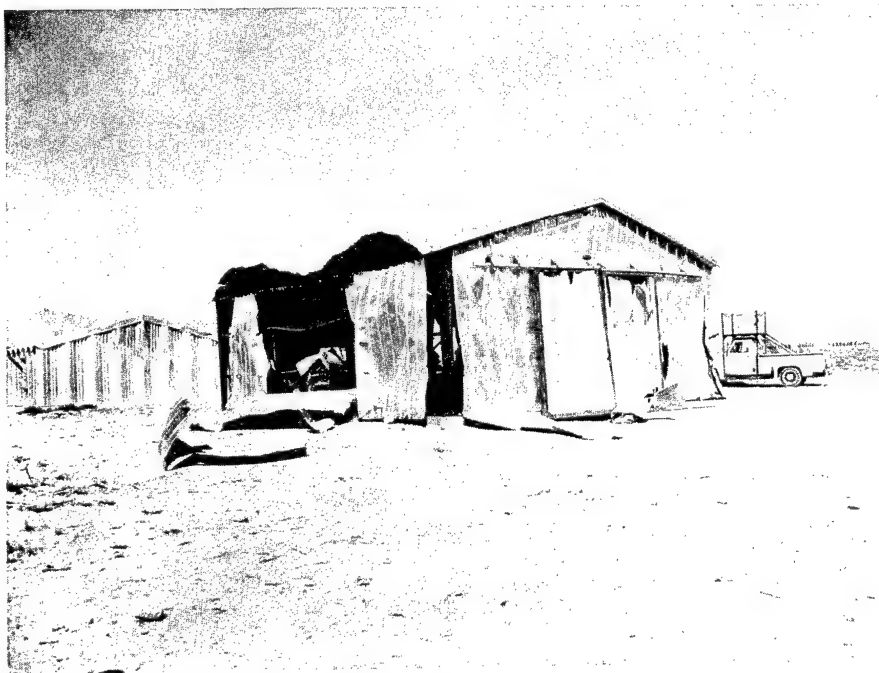
On the south wall the sheeting was all detached from girt fasteners, except for two segments that remained hanging along their top attachment to the eave members (Fig. 2.26). All the girts on the south side remained attached at their end connections to the main frames, as

Fig. 2.26—South side and east end of Reynolds-Butler Building 31.2-a1 after planned test.

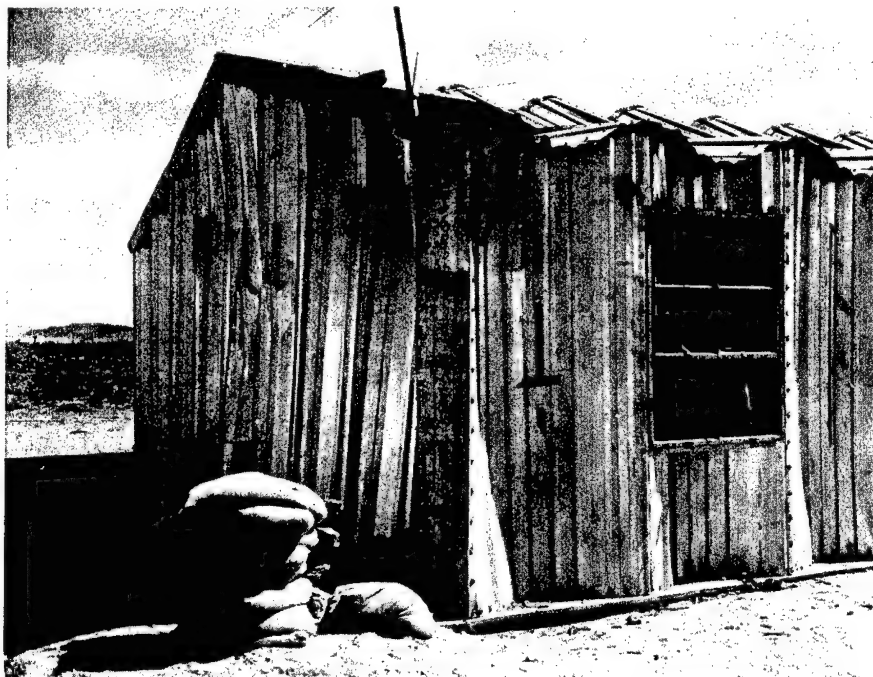
The ends of the building suffered minor damage, as shown in Figs. 2.34 and 2.35. The north half of the east end of the building was tilted toward the west, or center of the building, by varying amounts. In addition, the central panel was bent inward approximately 7 in. at mid-height. Along the sloping northeast corner of the roof, the inward tilting of the end wall segments (Fig. 2.35) varied from 11 in. at the panel next to the eave corner to 2 in. at the ridge. At the west end of the ridge, the end wall remained essentially plumb, but it was bent inward locally about 2 in. near the center. Also, adjacent to the west end, there was severe local buckling near the top, which can be noted from the interior close-up view shown in Fig. 2.36. At this point, also, can be noted the failure between the longitudinal end strut and its connection to the end wall of the building, with permanent displacement in the direction of the ridge line of about 4 in.

Fig. 2.35 — Northeast corner of Behlen Building 31.2-b1 after planned test.

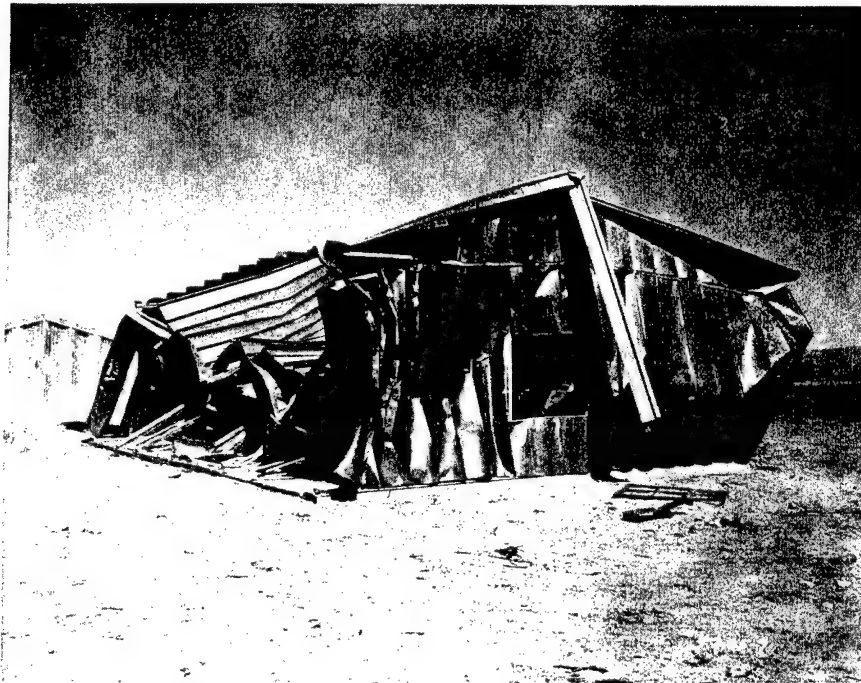
The north side of the building is shown in Fig. 2.37, which also indicates the sag in the roof. Figures 2.38 to 2.41 show various views of the crumpled ends and the south side of the building. Most of the wall segments remained on site, although the wall panels along the north side were largely torn loose from the wall sill connections, as shown in detail in Fig. 2.42, and one piece swept downblast about 50 ft. At the southwest corner of the building, the sill was also torn loose, as shown in Fig. 2.43. The wall paneling remained attached to the sill along 75 per cent of the east end and all the west end.

Fig. 2.38 — West end of Armco Building 31.2-d1 after planned test.

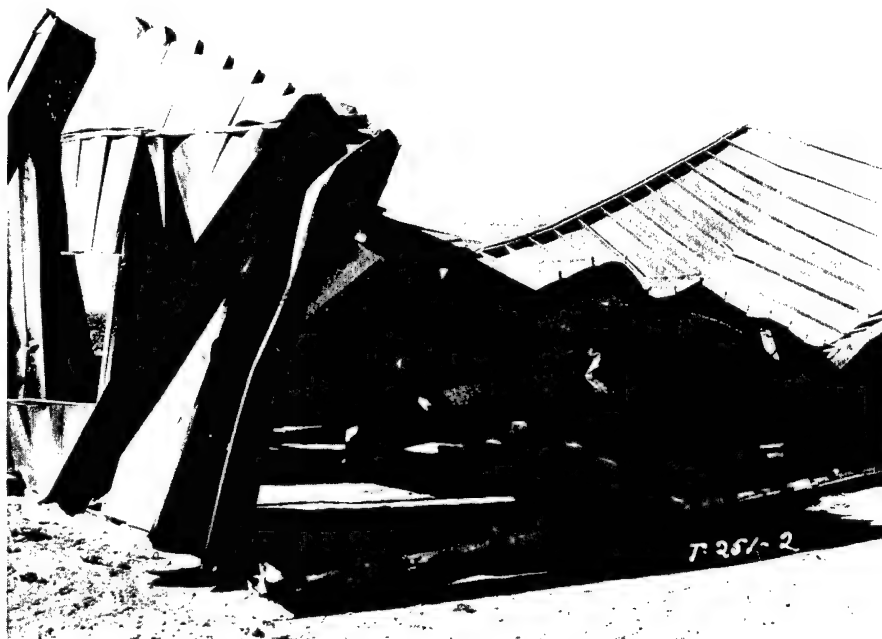
Fig. 2.39 — Northeast corner of Armco Building 31.2-d1 after planned test.

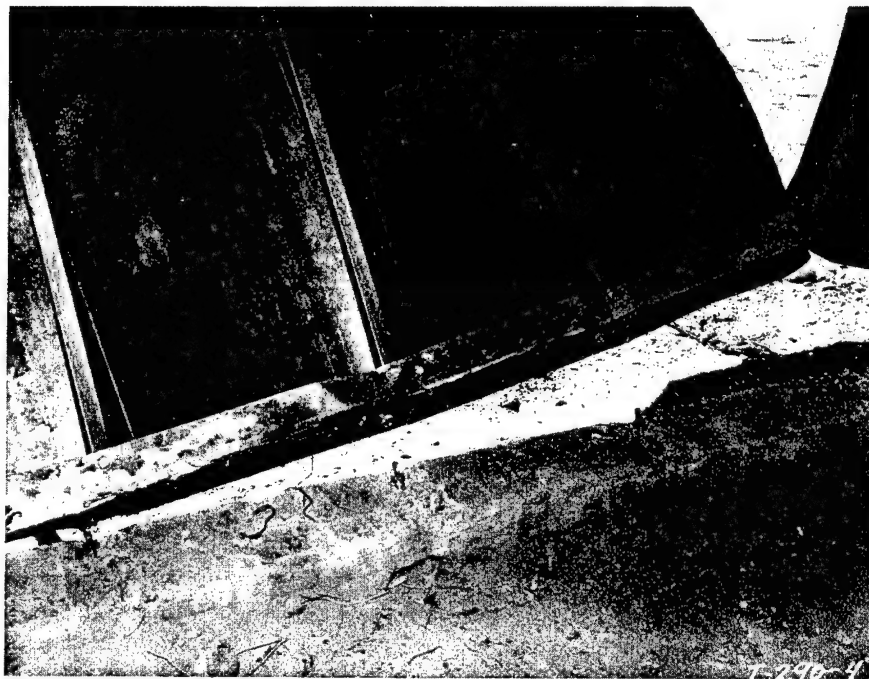
Fig. 2.43—Interior detail of sill at southwest corner of Armco Building 31.2-d1 after planned test.

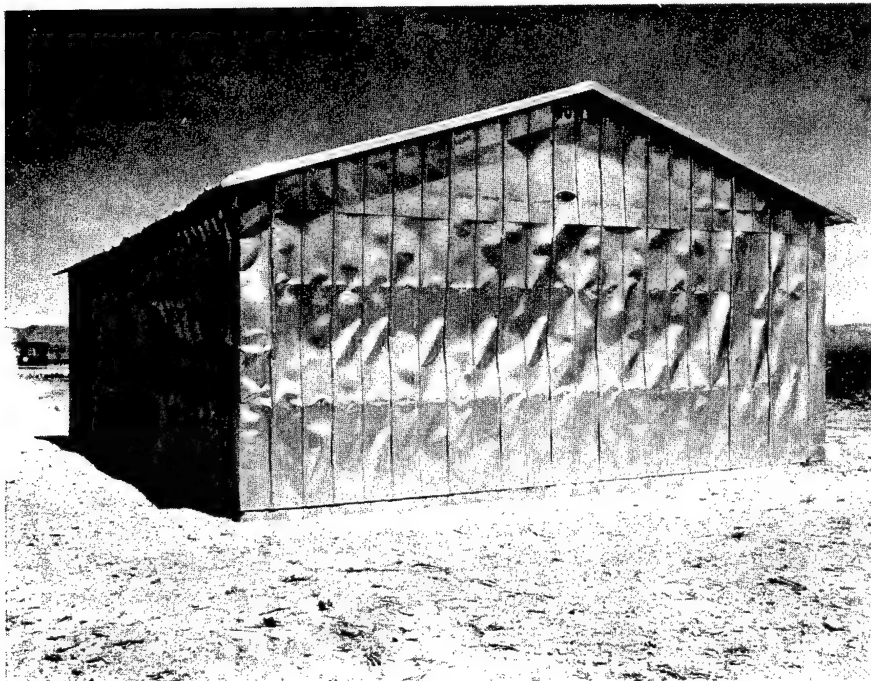
Fig. 2.48—West end of Reynolds-Butler Building 31.2-a2 after planned test.

A general description of these buildings is given in Sec. 1.3.2, and general drawings, are shown in Figs. 1.10 and 1.11. Over-all behavior during the unexpected test is described in Secs. 2.1.2 and 2.1.3, and behavior during the planned test is described in Secs. 2.2.3 and 2.2.6. Figure 2.1 shows the wall after the unexpected test, and Fig. 2.2 records the measured offsets of permanent wall deflection after both the unexpected and planned tests. Figures 2.3 to 2.5 show other views of damage to the walls and roof which resulted from the unexpected tests, and Figs. 2.46, 2.48, and 2.49 show the wall condition after the planned test at the 15,000-ft line.

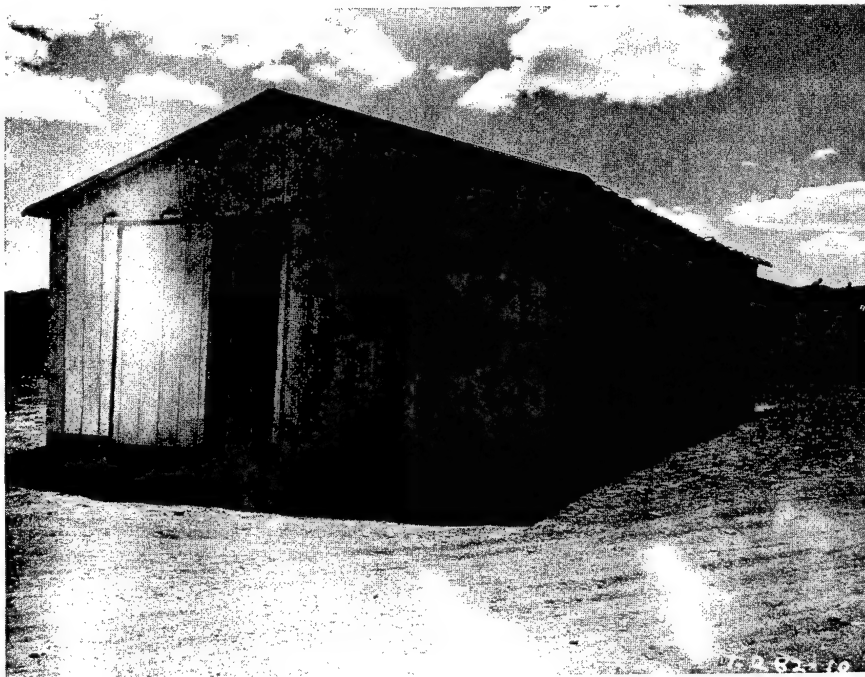
Fig. 2.49—East end of Reynolds-Butler Building 31.2-a2 after planned test.

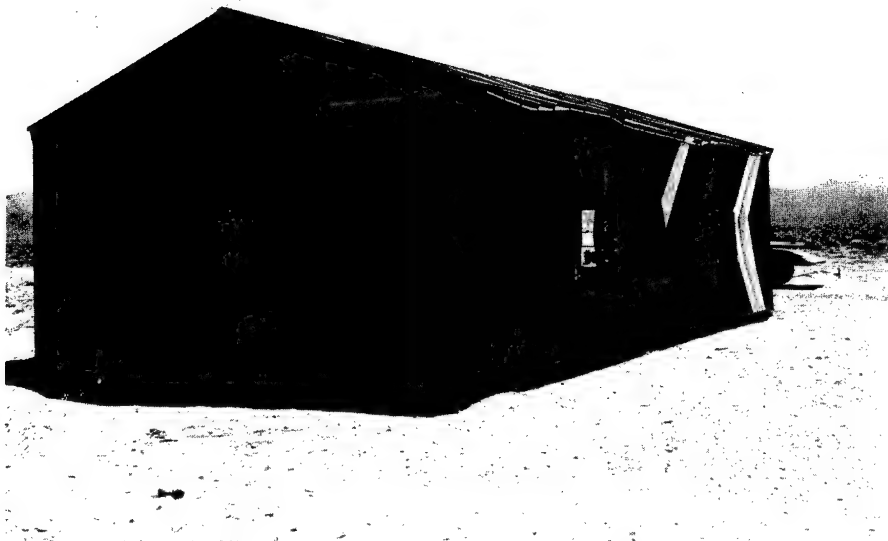
Fig. 2.52—East end and north side of Armco Building 31.2-d2 after planned test.

The wall panels at the door frames did not buckle or bend, thus retaining their original length, whereas bending of the remainder of the north wall caused a depression of the north eave line everywhere except above the doors, as shown in Fig. 2.51. Figure 2.52, looking along the north side, accentuates the bent appearance of the north wall, where maximum wall deflections were between 10 and 18 in., except adjacent to the end walls and door frames. Field offset measurements of both wall and roof deflections are given in Fig. 2.7.

As shown in Figs. 2.6 and 2.52, three of the four door panels, together with the window in the north wall, failed in both the unexpected and planned tests. This area amounts to 9 per cent of the total frontal area on the north side. As a result of these openings, an attenuated shock wave entered the structures, relieving to some extent the pressure on the outer wall and building up back pressure on the inside of the front wall. When the attenuated wave strikes the inside of the back wall, it is approximately doubled as a result of reflection. The reflected wave from the back wall returns to strike the inside of the front wall, and it is again approximately doubled, thus providing further relief in opposition to the load on the outside of the front wall. It is of some interest that, if this effect were not introduced into the present problem, the analysis would indicate that the wall of Armco Building 31.2-d2 at 15,000 ft would fail completely in the planned test.

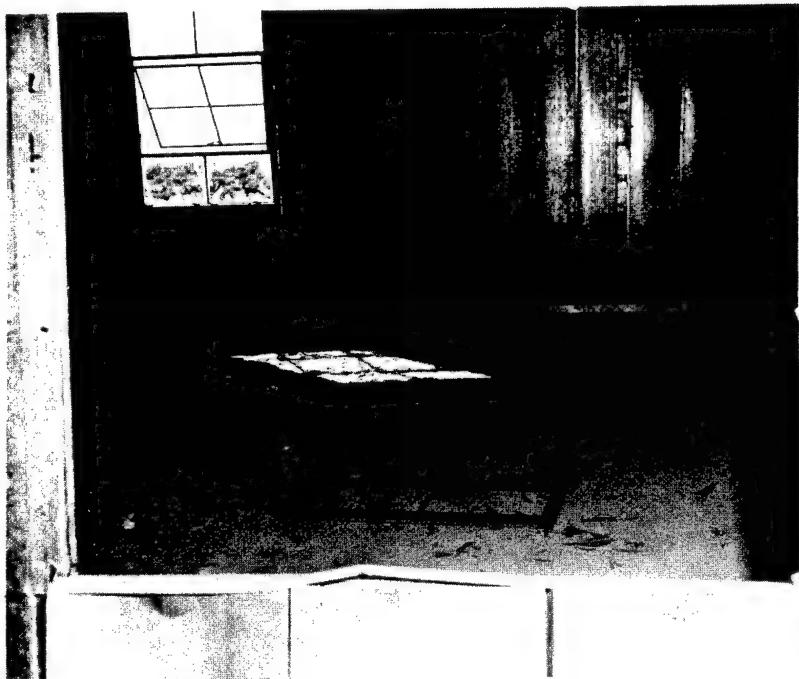
Fig. 2.53—View looking south into interior of Armco Building 31.2-d2 after planned test.

The entire window sash was blown inward, as shown in Fig. 2.53.
